<u>Location:</u>	Tiller Ranger Station
<u>Date:</u>	September 13 2014 - Current
<u>Time:</u>	N/A
<u>Personnel Involved:</u>	Donna Owens, Tiller District Ranger Terri Brown, District FMO Mitch Fuller, Facilities Maintenance Steve Marchi, RELM Staff Officer John Beagle, Assistant Forest Engineer Kayli Barber, Facilities Engineer Michelle Bernard, Civil Engineer John (Zeb) O'Connor, NU/DL Zone Facilities Lead Timberline Corporation, Contractor Western States Environmental, Contractor American Leak Detection, Contractor ServPro, Contractor Yeager's Plumbing, Contractor

Executive Summary

Photos and Descriptions

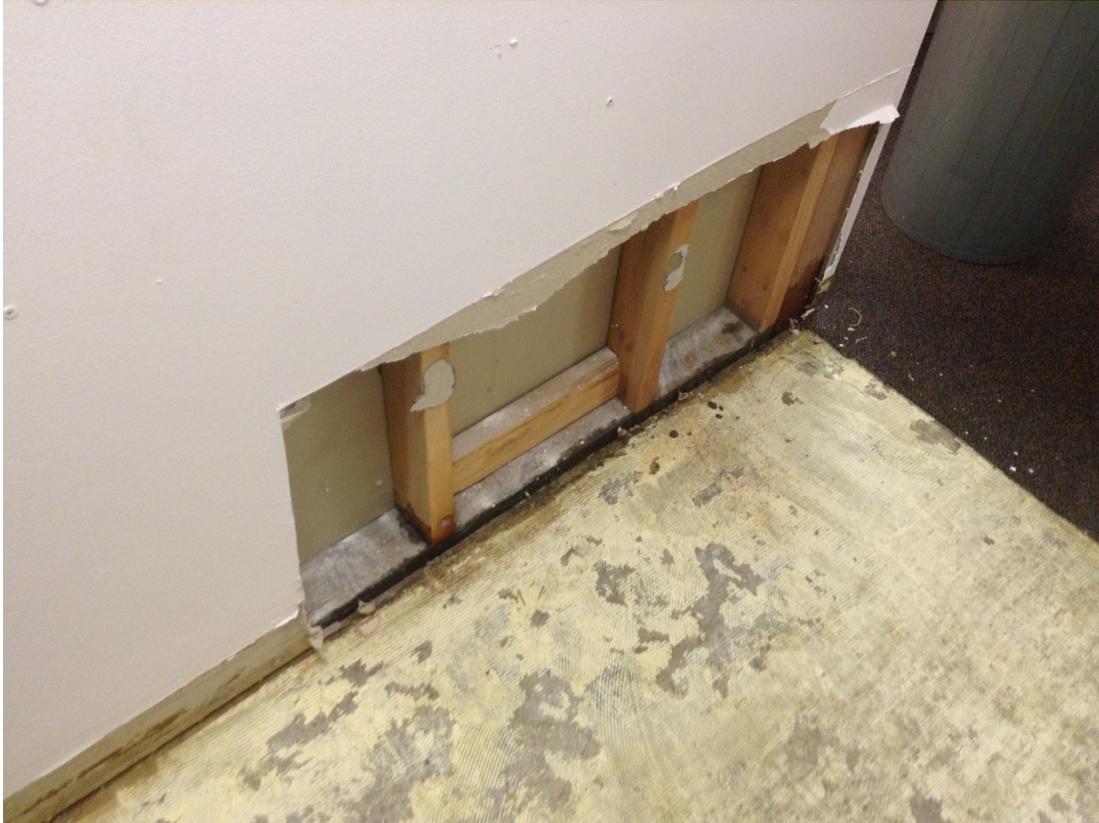
Figure 1 - "Ground Zero" for office leak (in hallway, opposite side of wall from break room)

Figure 1 shows the area that the leak was surfacing on Monday, September 15. The office design plans showed a potable water supply line in this general vicinity and it was believed that the line was under this wall.

Subsequent investigation by American Leak Detection showed the leak was actually on the other side of the break room wall (shown in Figure 1).

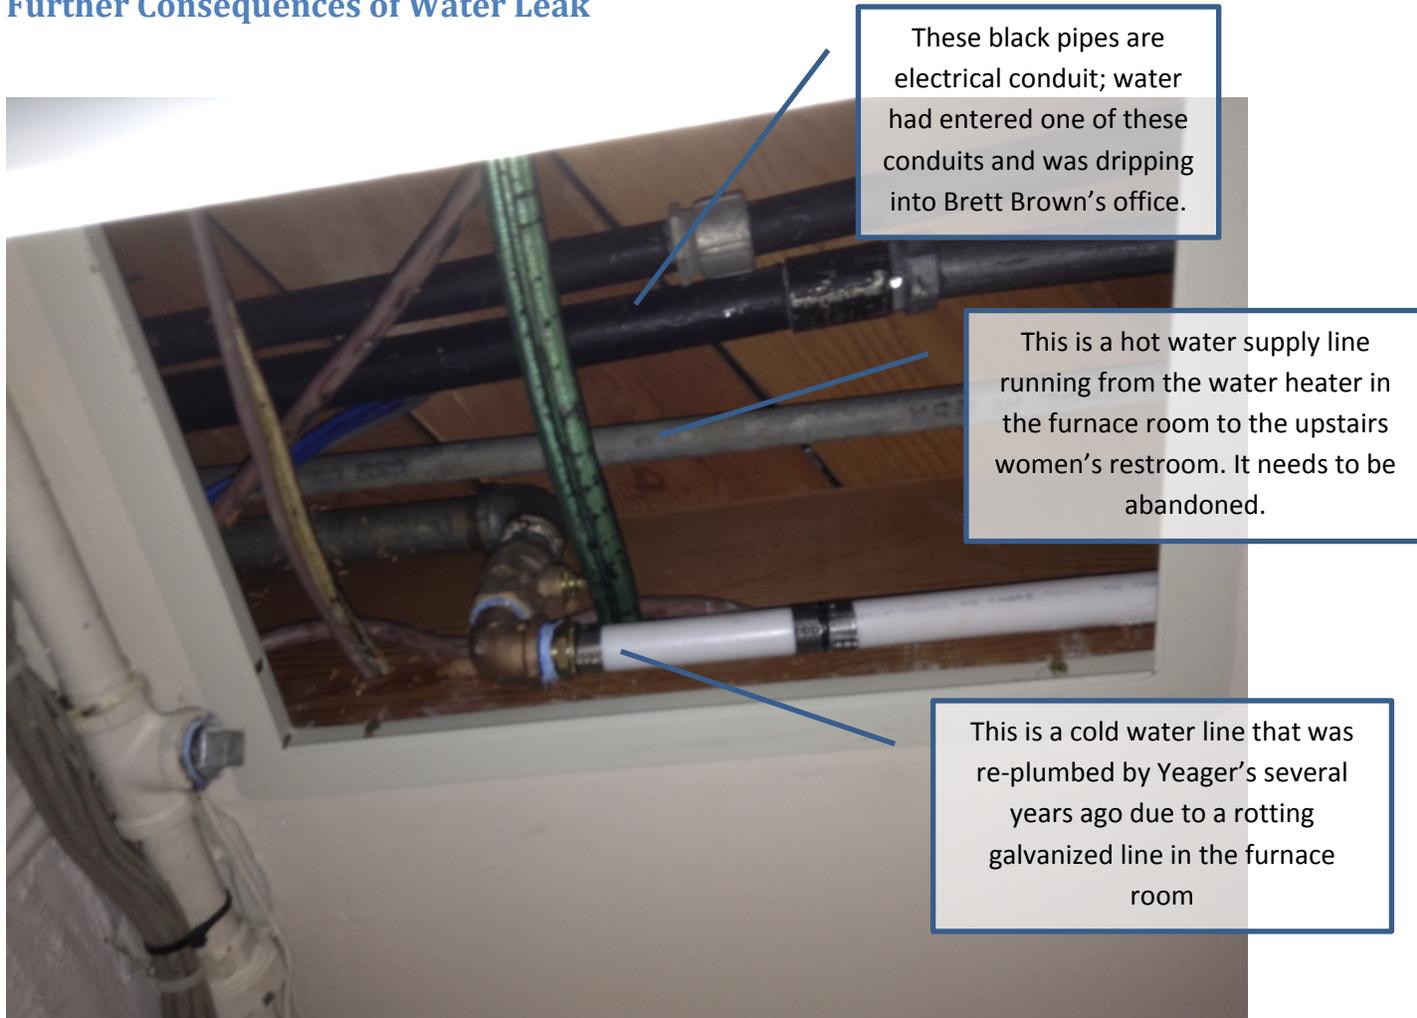
Figure 2 - Lines in hatch above Brett Brown's office

Figure 2 shows the interconnection of lines between the fire office portion of the building, and the main office. Note that water had entered the electrical conduit and was dripping into Brett's office. This probably prevented water from backing all the way up to the electrical panel, which could have been catastrophic.

- Burying galvanized pipe within slabs was not a good practice – but it was done well before any of us inherited the building.
- After tracing out the lines, we have developed a plan to abandon all galvanized subsurface piping in the building. This plan will be developed into a contract.

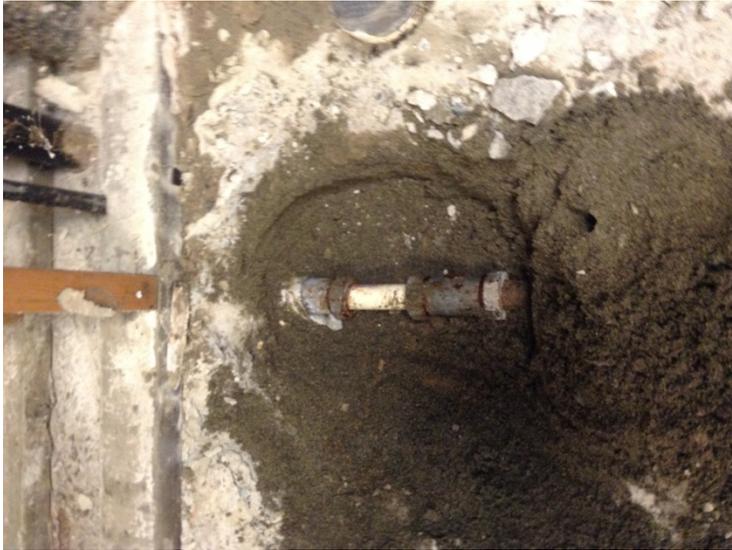
Figure 3 – Service line from main trunk to leak location (in Kitchen Area)

The decision was made not to dig at the “X” (mark on the floor showing leak location) as it was becoming clear that the “tee” was likely near the wall and in line with the “X”. Figure 3 shows the area that was dug up in the kitchen area. Very poor plumbing repair work had occurred there in the past and the pipes removed from this location were in very bad shape (see Figure 4 and Figure 5).

- Given the state of the pipes it is imperative to develop a plan to bypass all underground galvanized pipes.
- It was only a matter of time for this failure to occur – the pressure spikes only exacerbated this situation. It is likely these pipes have been leaking underneath the slab for years.

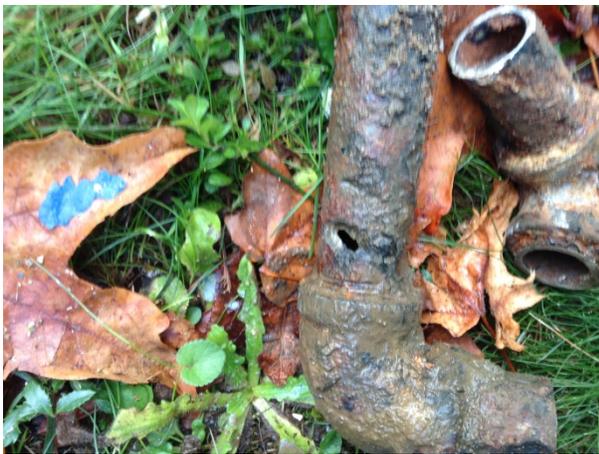
Figure 4 - Corroded Pipe

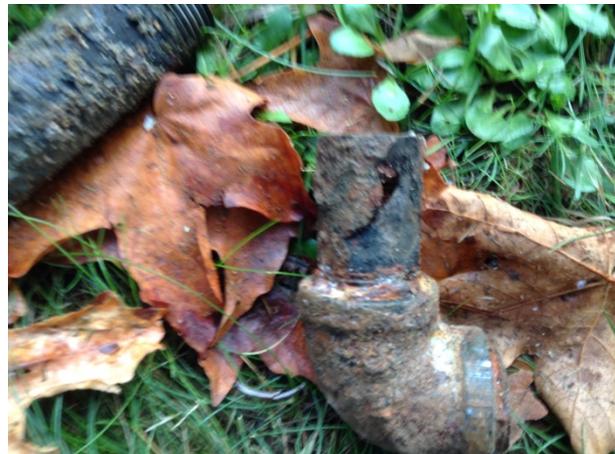
Figure 5 - Corroded Pipe

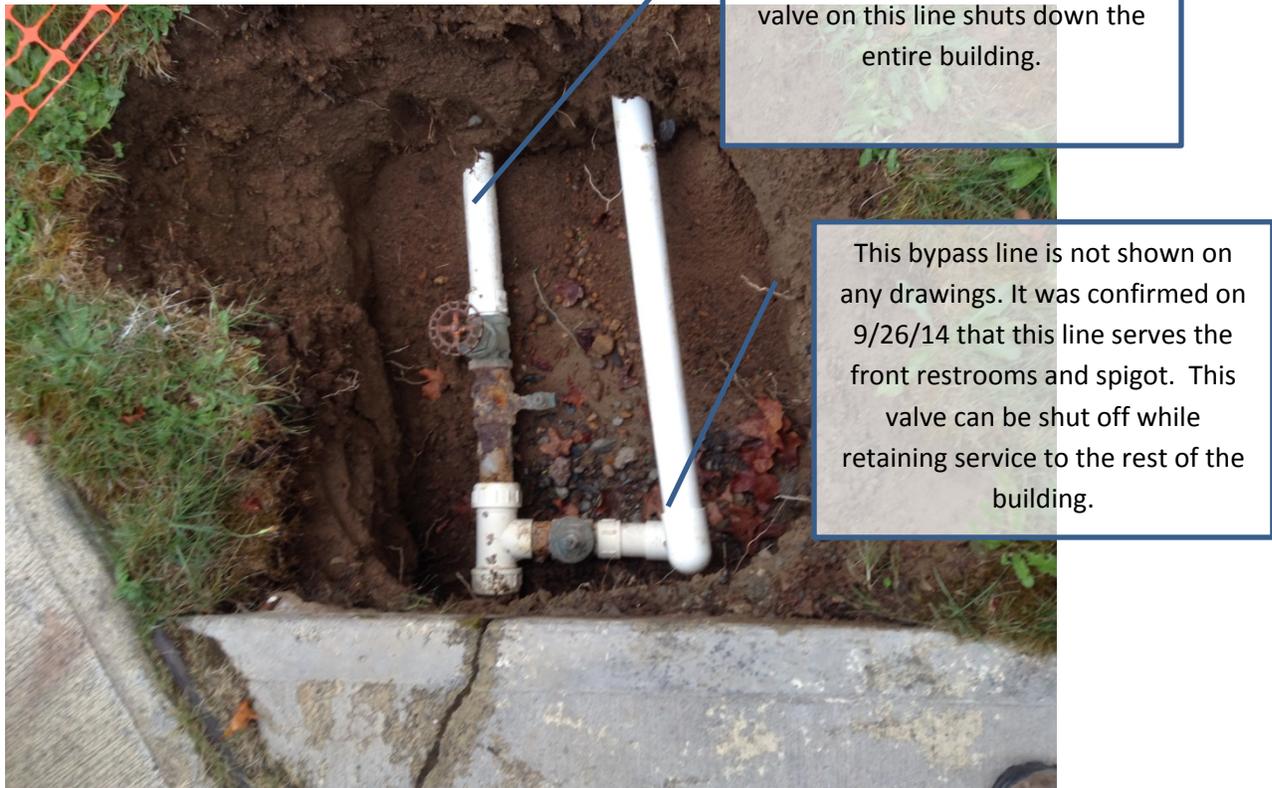
Figure 6 - Valves located near Ranger's Office

Initially, we had planned to correct the valve cluster shown in Figure 6 so that the main building and the front restrooms could be shut off independently. After discussion with the plumber, the better long-term solution will be to use this bypass line to feed the entire ranger station. There will still be an opportunity to valve the front bathrooms off separately from the rest of the building.

Also of note, Figure 6 shows a past repair that was done improperly. Threaded PVC has been threaded into galvanized fittings. Poor practices make this another weak point for failure.

- The main line feeding the building will be capped (in conjunction with re-plumbing the Ranger Station) and this valve cluster will be re-plumbed correctly.

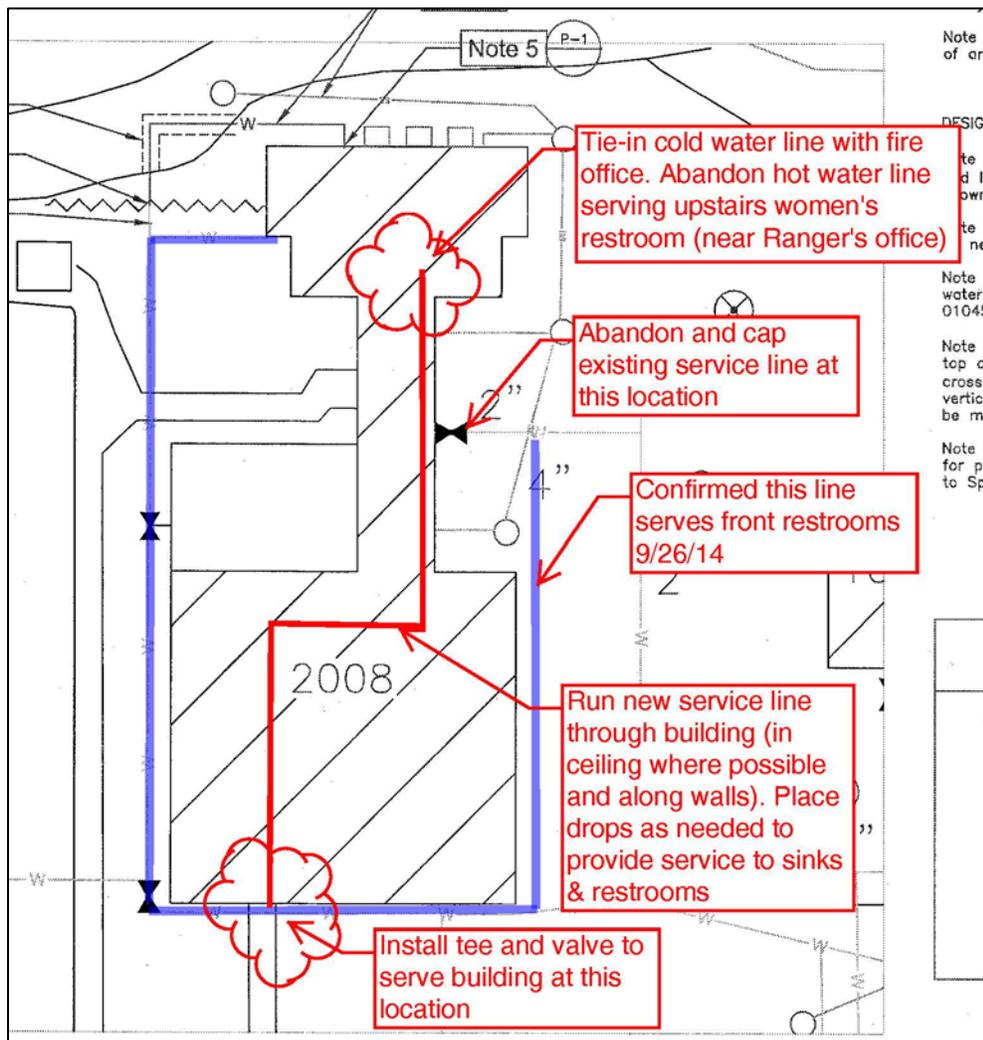
Figure 7 - Schematic of New Waterline (shown diagrammatically)

Figure 7 shows a plan to abandon all buried galvanized piping in favor of a new, overhead, PEX (cross-linked polyethylene) service that will run through the building. Pipe will run in attic/drop-ceiling spaces where possible; in some areas it will be exposed (but a decorative soffit could be built if it is objectionable).

Note: in the above scenario, all water heaters will be replaced with on-demand, tankless heaters. This will eliminate both the cold and hot galvanized lines that are buried beneath the slab.

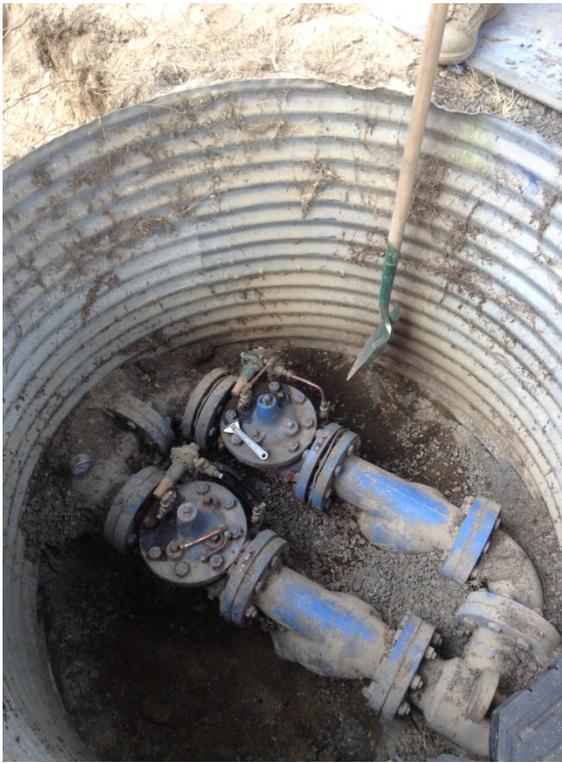
Figure 8 - Pressure Reducing Valves

There are two sets of Pressure Reducing Valves (PRVs), with two PRVs per station. We therefore have a total of four PRVs that work in conjunction to reduce water pressure from over 200 psi to approximately 60 psi at most services. The PRVs shown in Figure 7 had been damaged due to a “homemade” manhole and lid that does not fit properly. This lid was accidentally dropped into the manhole and caused damage to the last working PRV.

When the service technician examined the PRVs he found that they had never been serviced. A diaphragm that he removed had a date stamp on it from 1967. Those diaphragms should be changed out every five years.

- Our O&M Contractor will build annual inspection and maintenance of these PRVs into their standard procedures.
- A new manhole/lid system will be designed that is more appropriate for this installation; and will be designed so the lid cannot fall into the hole.

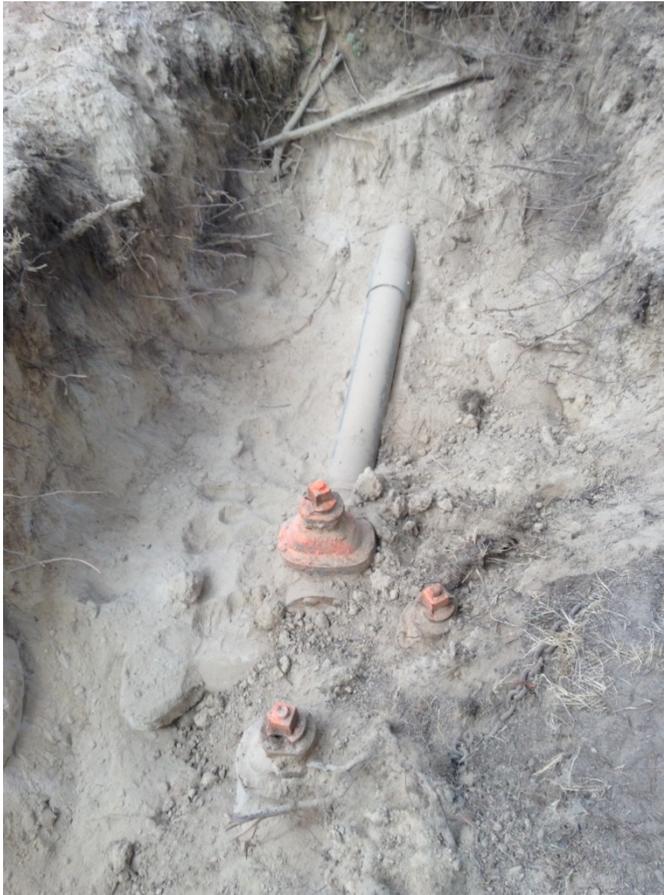
Figure 9 - Unknown Water Valves

In the process of fixing the PRVs, it was discovered that a valve cluster had been installed just outside the PRVs but had long since been buried. As such, the valves had never been exercised and were unknown to operators. These valves are important to operators as it allows them to isolate sections of line for repair.

- Valve boxes will be installed so that valves can be actuated from the surface
- These valves will be added to the O&M contractor's standard valve exercising procedures to ensure the longevity of the valves.
