Asbestos Survey Report

Umpqua National Forest

**Tiller Ranger Station
Residence #1210**

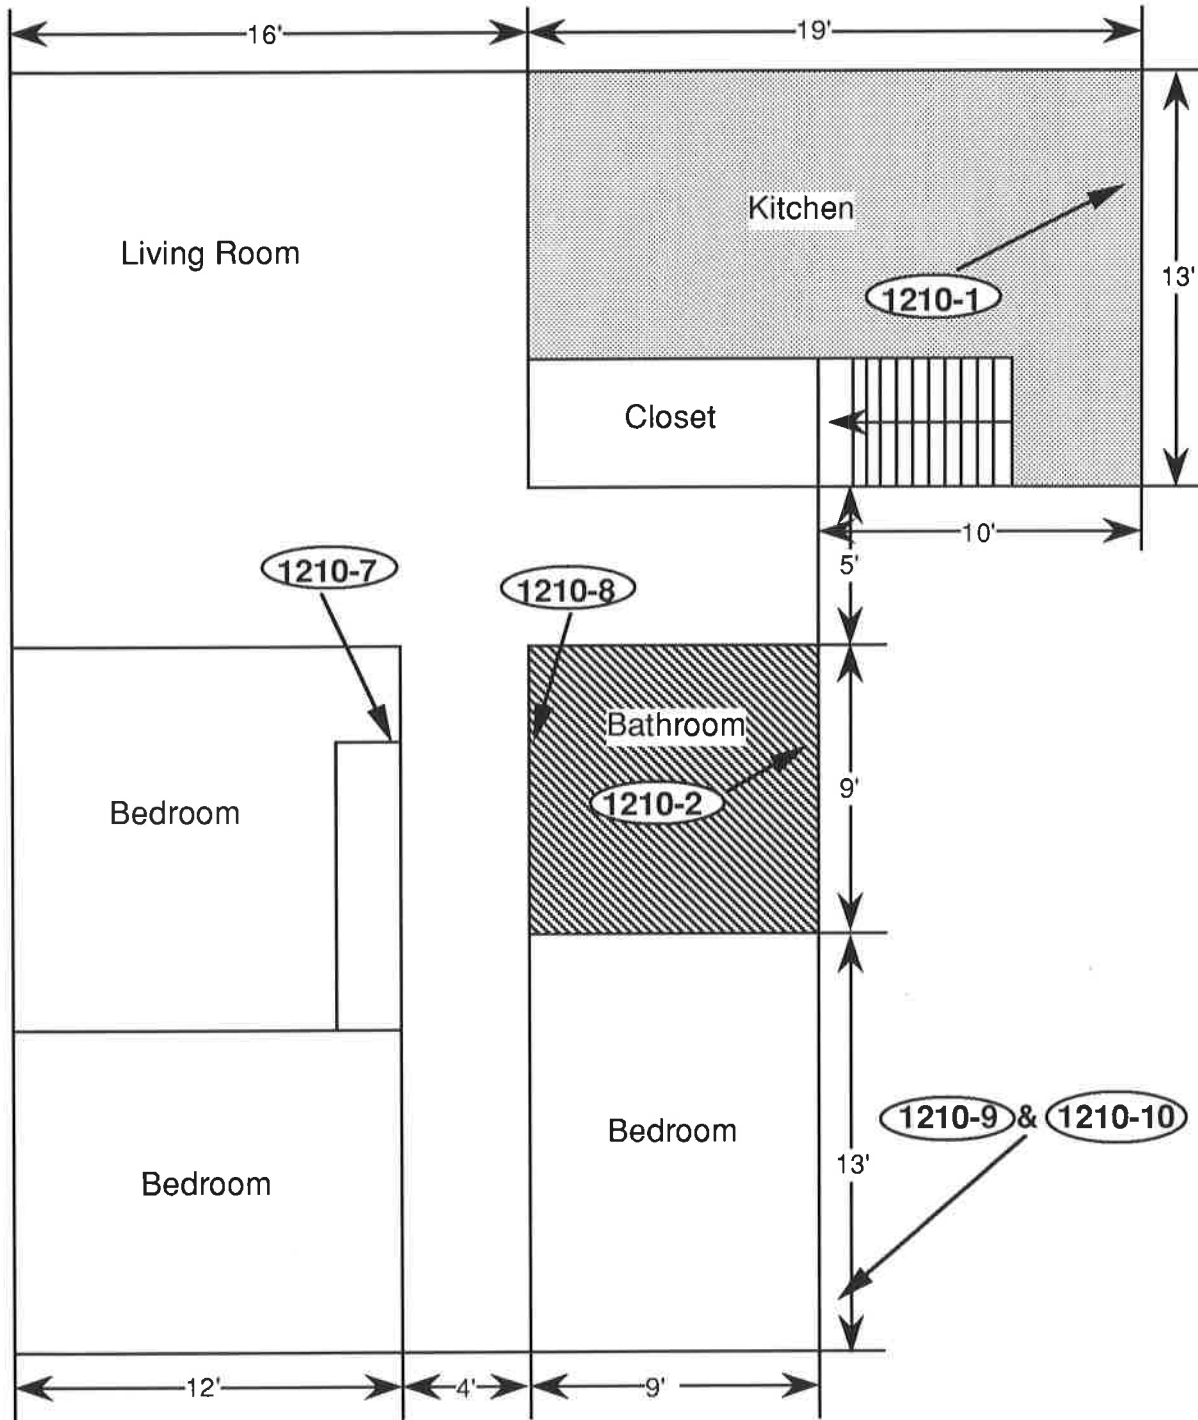
Umpqua National Forest Tiller Building #1210 Main Level

- H.A. #1 Asbestos containing sheet vinyl
- H.A. #2 Asbestos containing sheet vinyl

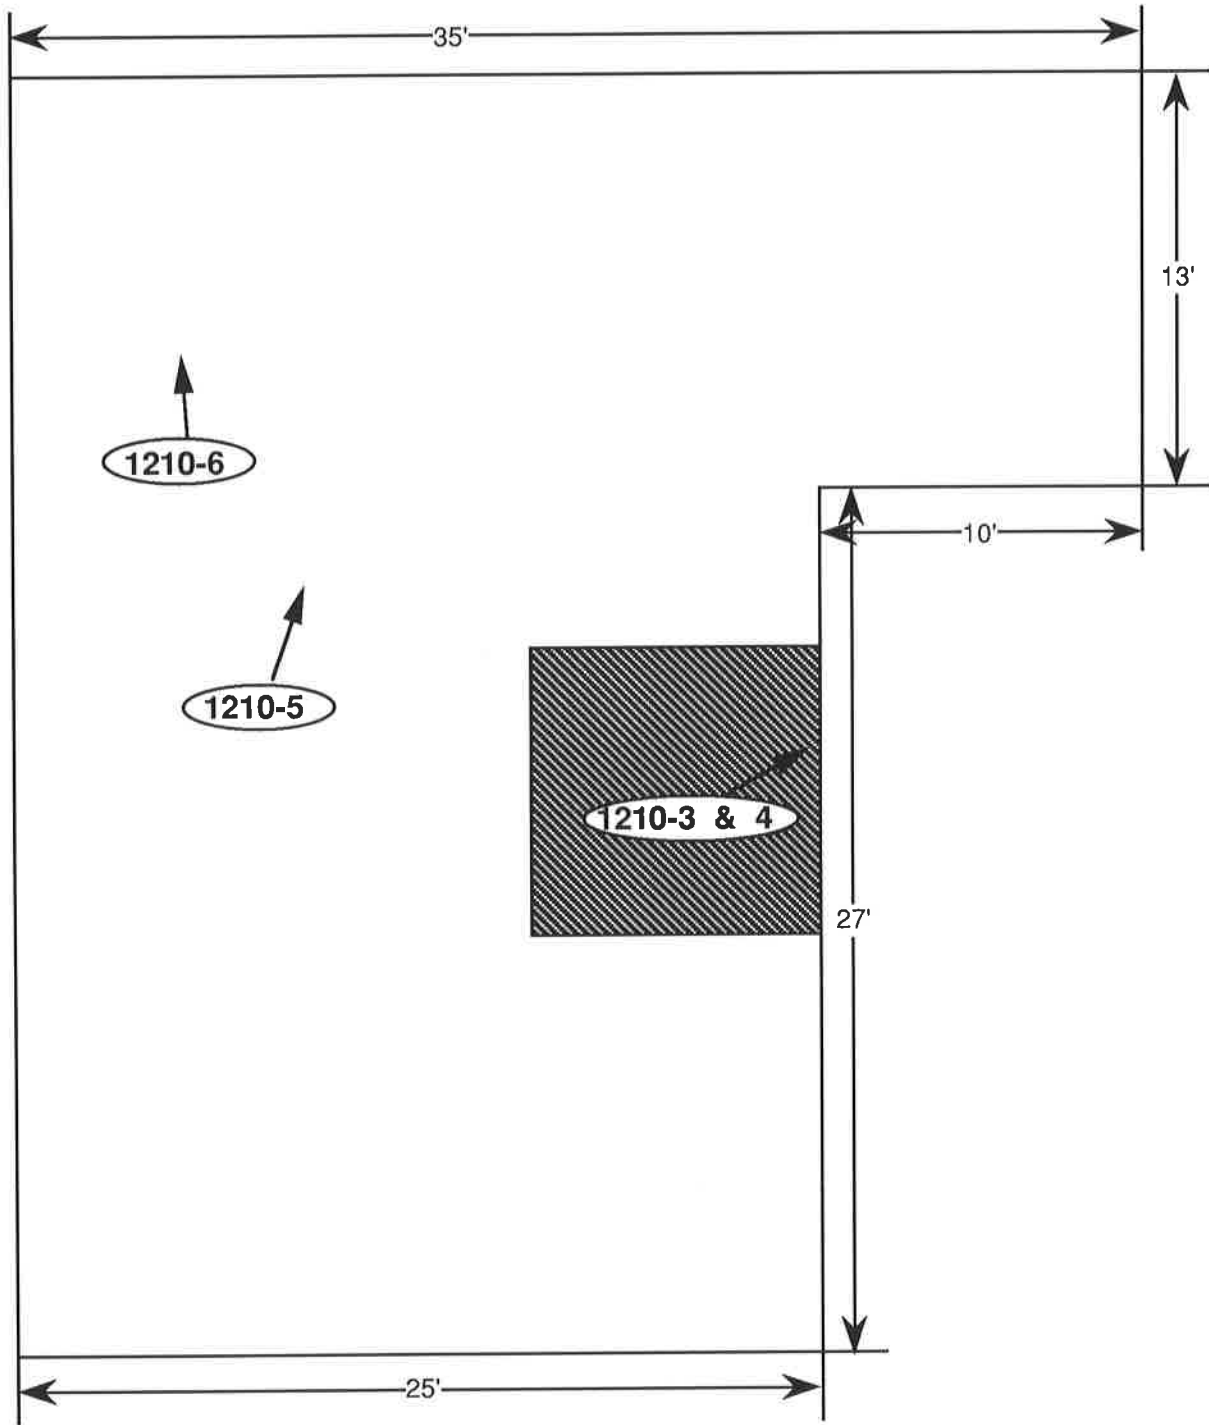
Umpqua National Forest Tiller Building #1210 Basement

H.A. #3

Asbestos containing 9" x 9' floor tile
